# Two big earthquakes

# Aftermath of the catastrophe

# Damage to the river embankment

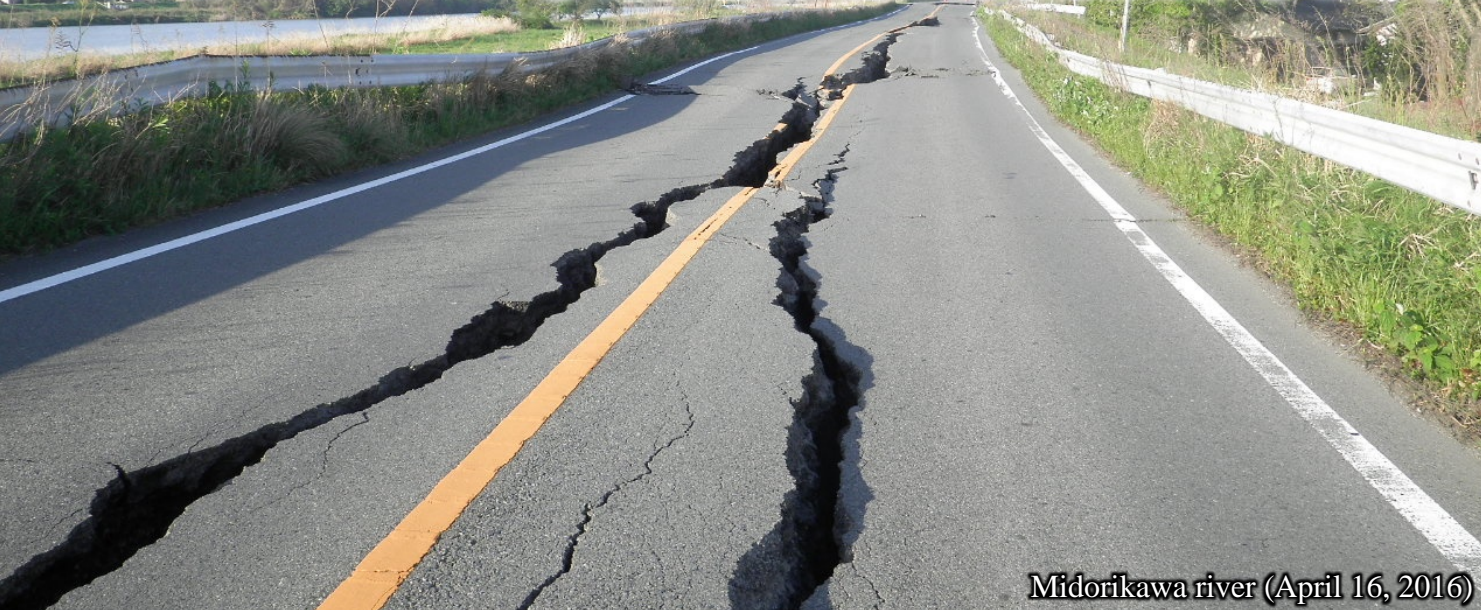
Midorikawa river (April 16, 2016)

**The river embankment experienced serious fractures and instances of significant subsidence.**

After the big earthquake, 172 such cases of fracturing or subsidence were observed in the Midorikawa river system, Shirakawa river system, and Kikuchikawa river system. All these three systems are managed by the MLIT. Numerous other cases of such damage were likewise observed in the rivers managed by local authorities. Since the rainy season was imminent, urgent restoration activity was required.

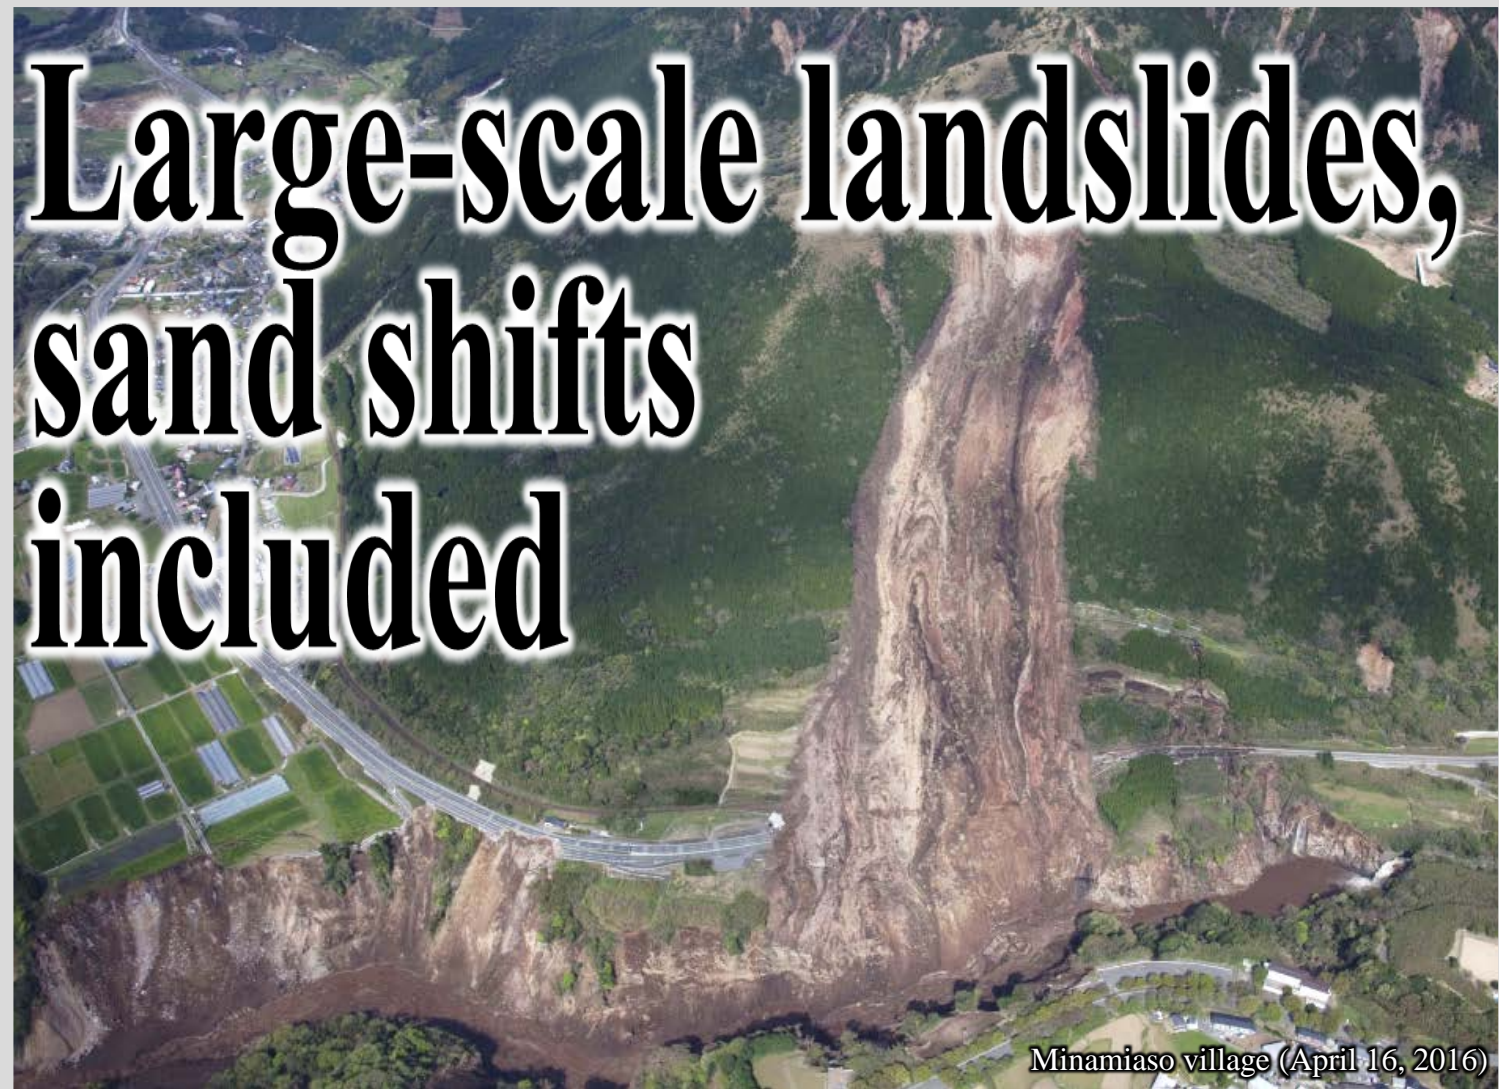
Minamiaso village (April 16, 2016)

**Large-scale landslides, sand shifts included.  
Around 0.5 million square meters of earth and/or  
sand collapsed instantaneously.**

On April 16, the second large earthquake caused a particularly large landslide, 700m long by 200 wide, in the Aso-ohashi district village of Minami-Aso, in Kumamoto. Numerous other landslides also occurred, especially in the Aso area.

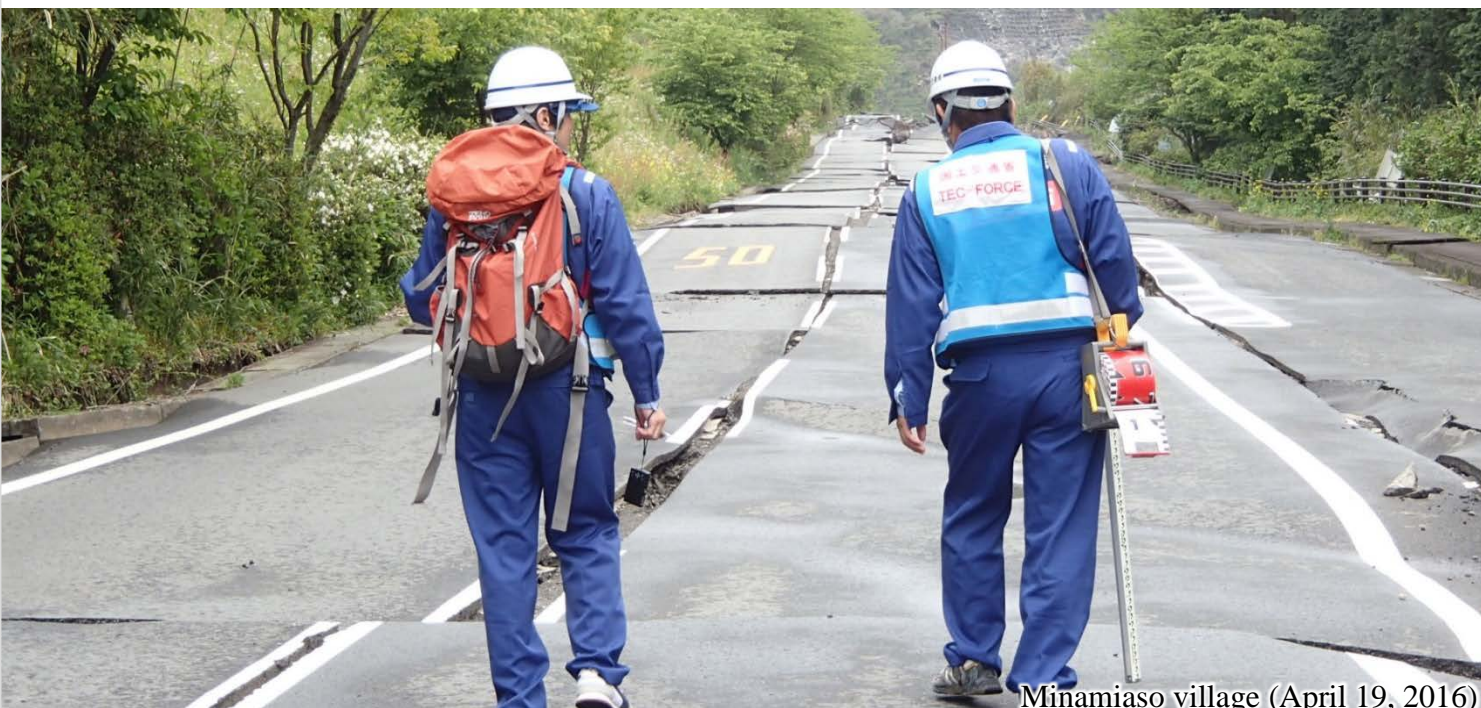
Minamiaso village (April 19, 2016)

**Land transport arteries such as national route 57 and the Houhi rail line were cut.**

In particular, one major landslide cut both national route 57 and the Houhi rail line, either of which is important as a transport link between Kumamoto prefecture and Oita prefecture. Moreover, this same landslide collapsed Aso's big bridge on national route 325. This was the only bridge connecting Kumamoto's city center with the Minami-Aso area. These disruptions made it difficult for emergency vehicles to transport those goods, foods, and other materials which the situation urgently required. As a result, the local populations experienced long delays in returning to normalcy.

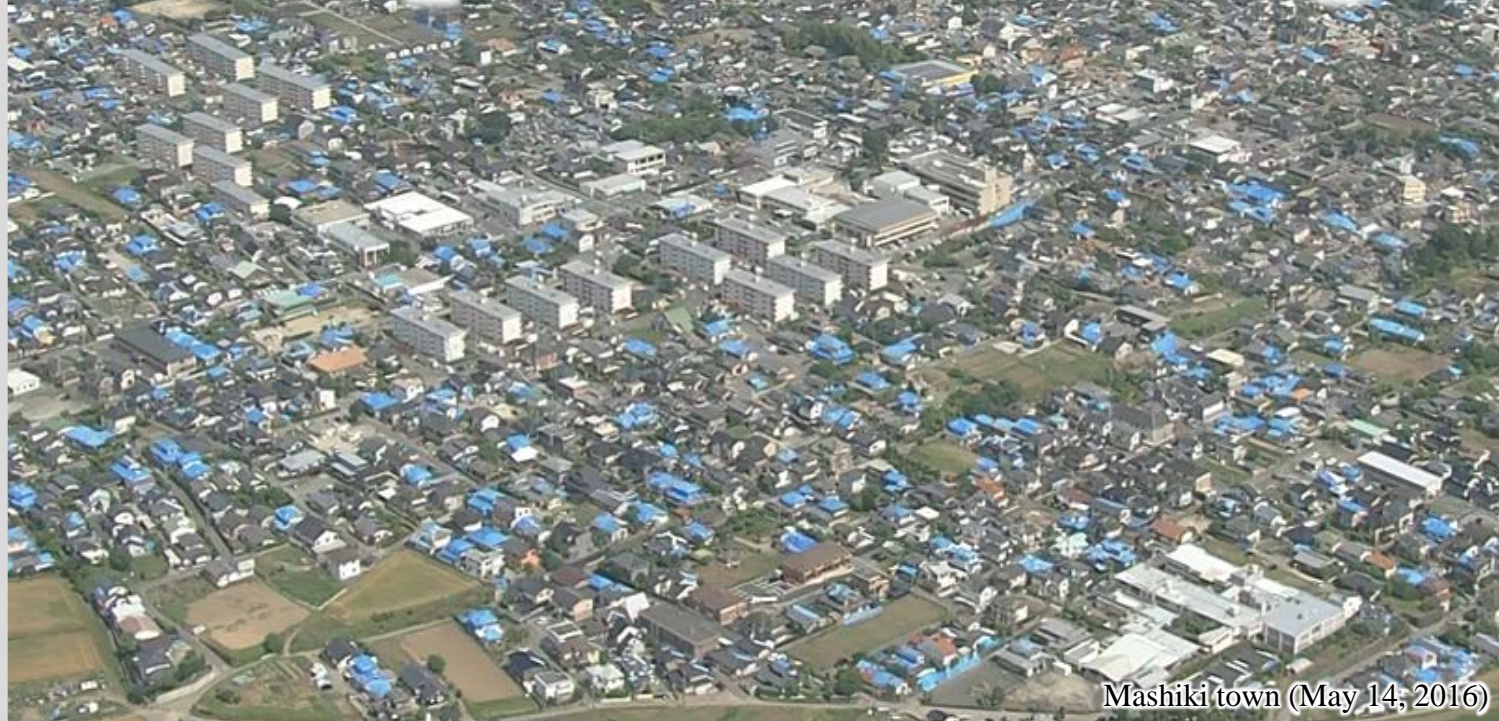
Mashiki town (May 14, 2016)

**A large number of houses, other buildings, and miscellaneous facilities, including an important national cultural property, collapsed.**

Due to the two big earthquakes alone, 8,000 or more houses caved in completely, and 180,000 or more were half-destroyed, or less severely but nonetheless seriously damaged, in the Kumamoto city area, Mashiki town, and Nishihara village. Also, many important national cultural facilities, including Kumamoto Castle and the Aso Shrine, were damaged seriously.

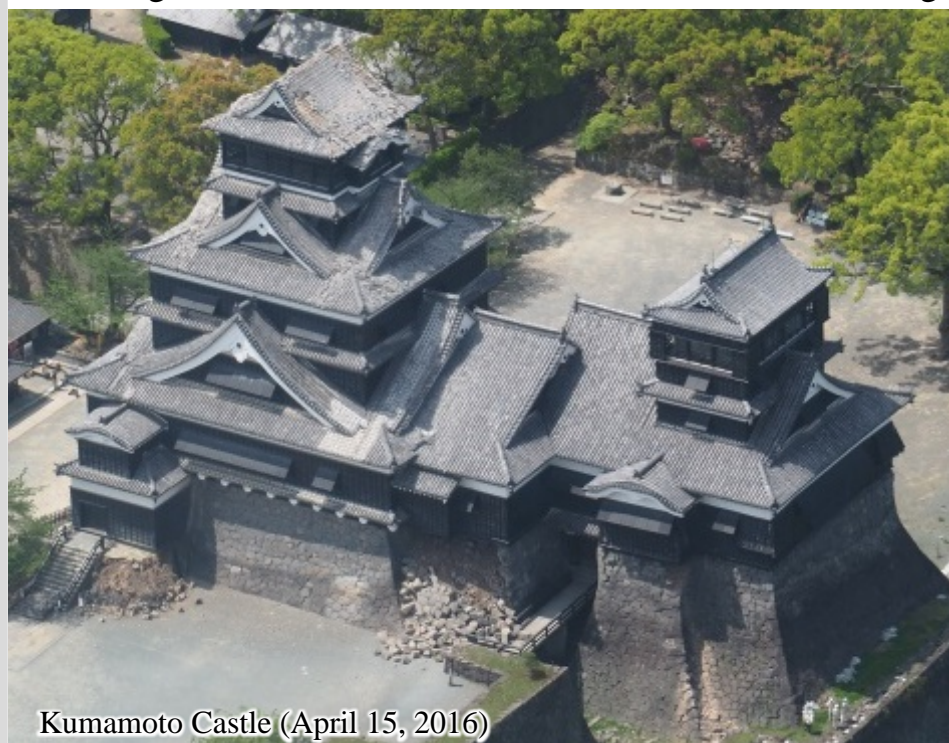
Kumamoto Castle (April 15, 2016)

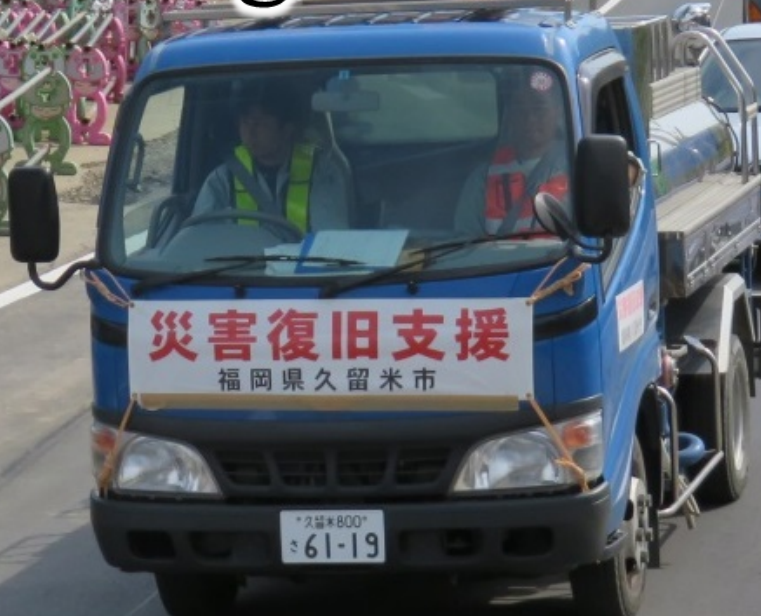
Restoration completed in 1 week  
(National Route 443 Mashiki town  
Terasako area)

The medical facilities of the Aso campus of Tokai University had to deal with a large number of earthquake victims immediately after the first quake occurred. This required that an emergency route to that campus be opened as soon as possible. This was done in only three days after the first seism struck. Additionally, a major prefectural road, the Gairinzan Otsu line, nicknamed the "Milk Road", was also opened only 4 days after the emergency began. These operations involved detouring relative to a key trunk road, National Route 57. Also reopened promptly were such other roads as National Route 443 and the Takanohara line, aka the "Green Road." Within one week after the crisis began, in fact, almost all main roads were restored to service and being used to help save the lives of evacuees.

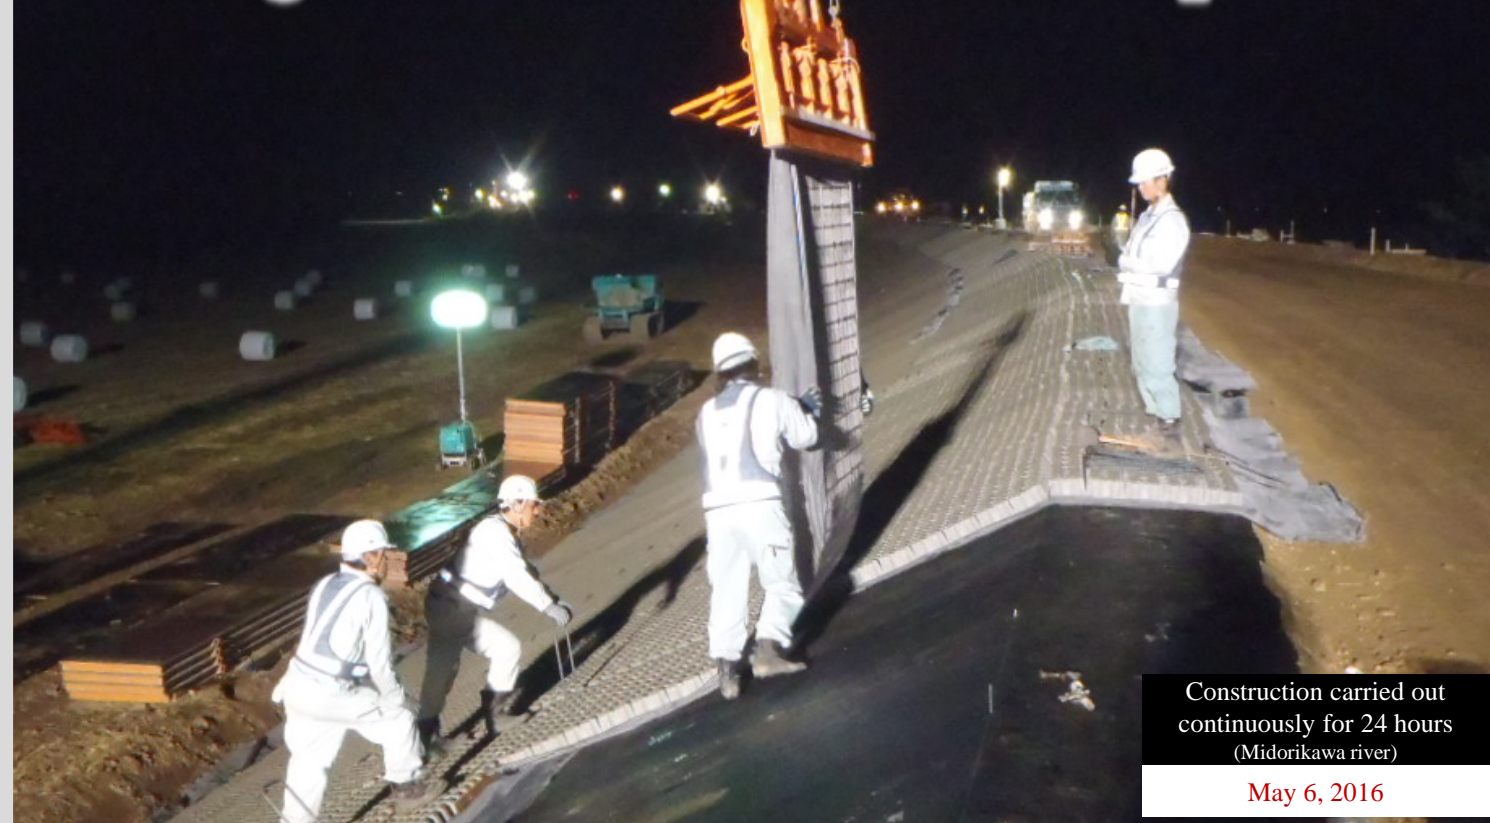
Construction carried out continuously for 24 hours (Midorikawa river)

172 points on the Midorikawa River system, the Shirakawa River system, and the Kikuchi River system were designated as "requiring prompt reconstruction." Among these, the less critically damaged points were dealt with quickly. On the other hand, 11 points were categorized as "severely damaged" and imperatively had to be put right before the rainy season began, to say nothing of the risk from typhoons. The MLIT completed the necessary work by May 9th through 24 hours of nonstop emergency reconstruction carried out in cooperation with private construction firms.

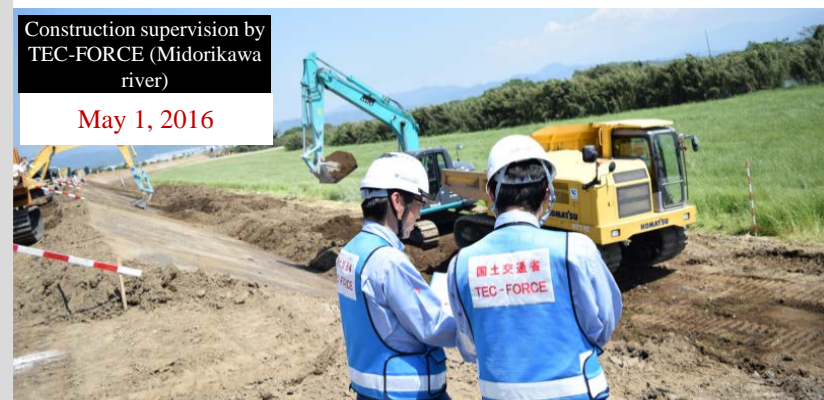
Construction supervision by TEC-FORCE (Midorikawa river)

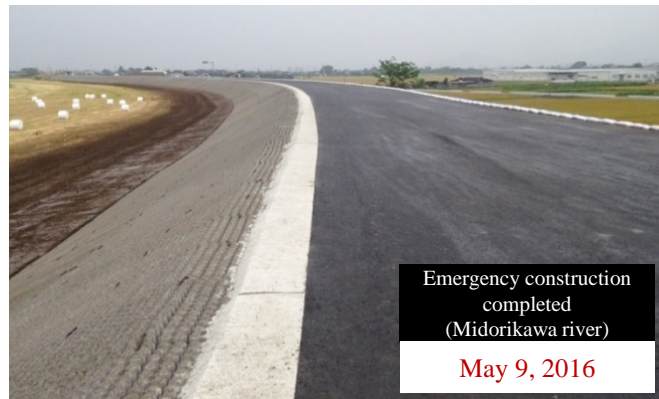
Emergency construction completed (Midorikawa river)

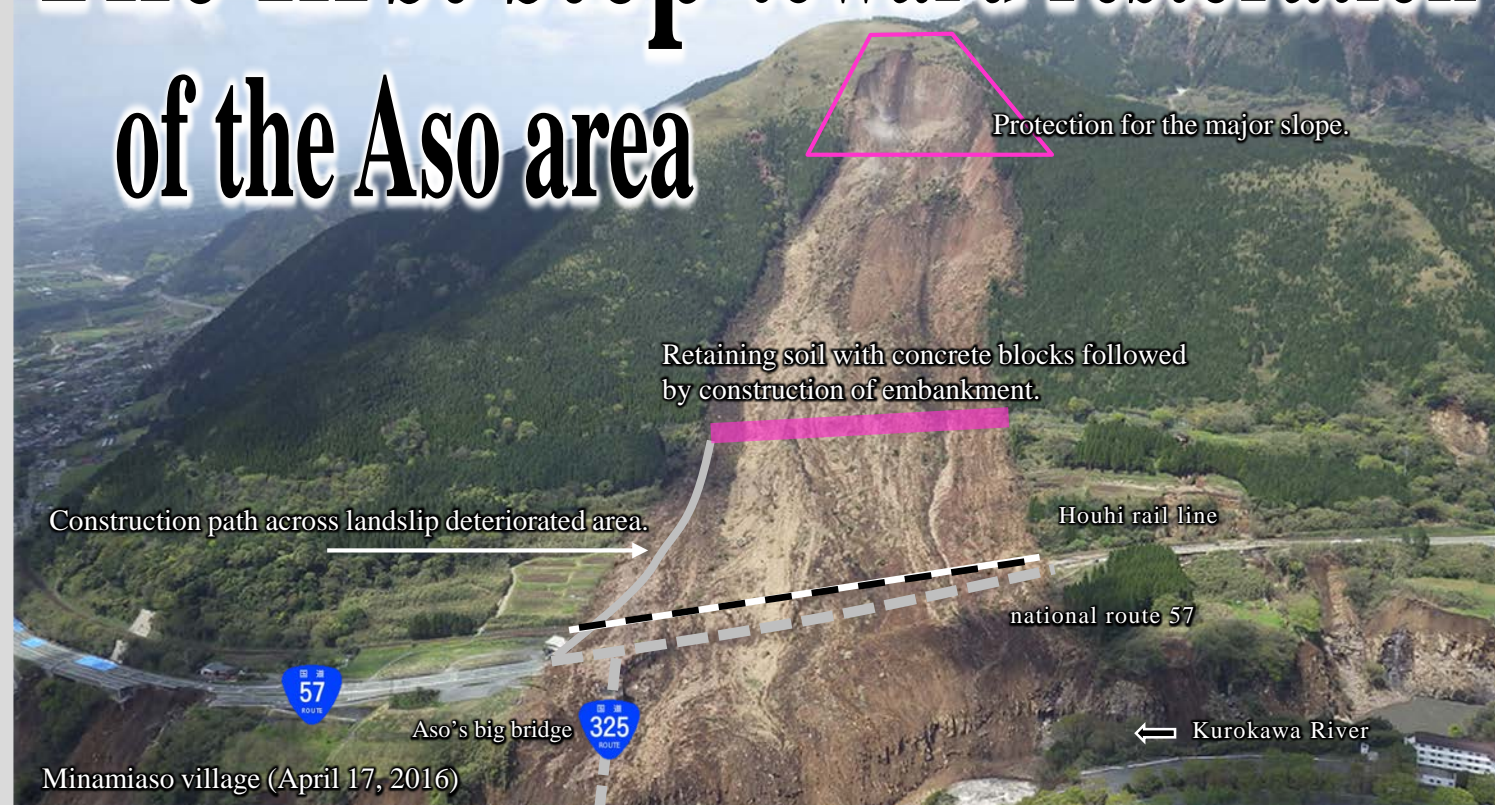
**In order to begin recovery and restoration rapidly, urgent construction works were undertaken to secure major land slope.**

The massive earthquake which occurred on April 16 cut the trunk route from Kumamoto city to the Aso area. As the first step toward rapid recovery and restoration of the damaged section, on May 5 the MLIT began urgent work to reverse and control the resulting erosion. To assure the construction workers' safety, this has been done with heavy unmanned construction machinery.

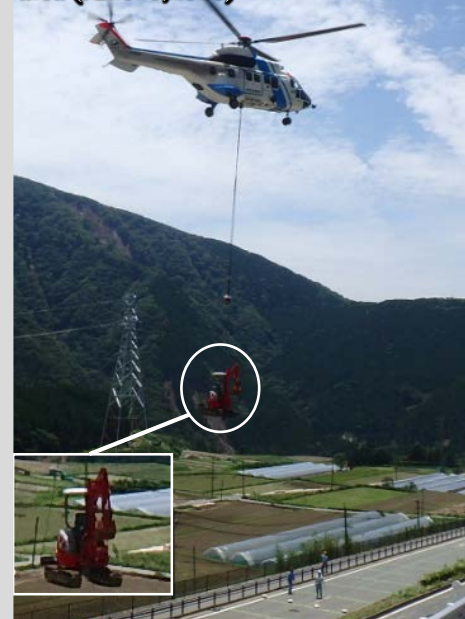
Carrying out retaining operation and building embankment (June 9, 2016)

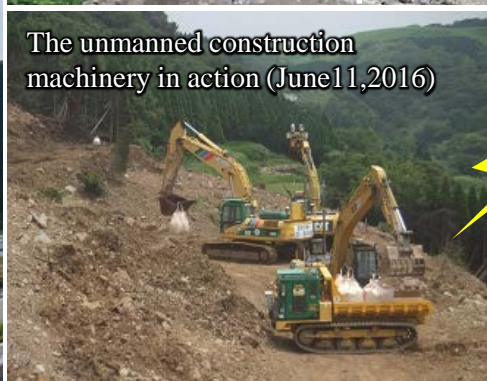
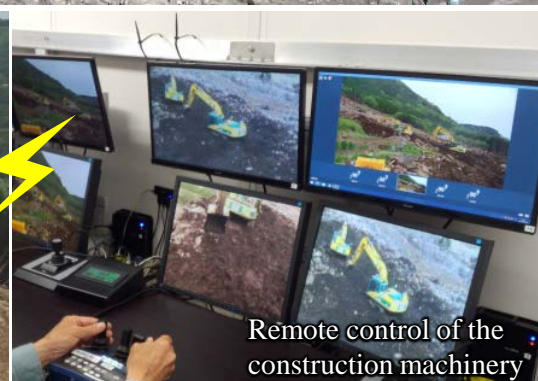
Remote control of the construction machinery

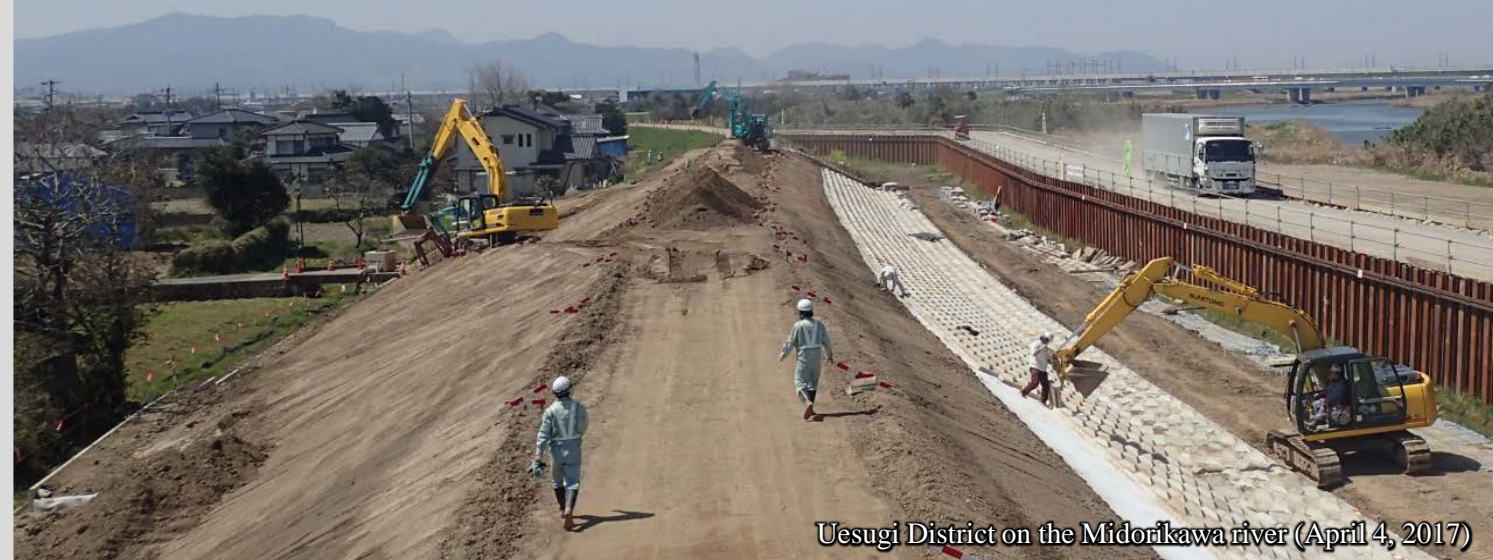
Uesugi District on the Midorikawa river (April 4, 2017)

## Full-scale repair work of defective sections of river embankments is on-going.

Based on the work of the Committee for investigating damage in Midorikawa and Shirakawa river area, MLIT determined what damages the earthquake had done to the embankments, decided how to repair them, and made an arrangement to monitor the situation long-term. At present, MLIT is concentrating on repair work for 40 sections on Midorikawa and 12 sections on Shirakawa. The intention is to complete the repair by the end of the rainy season this year.

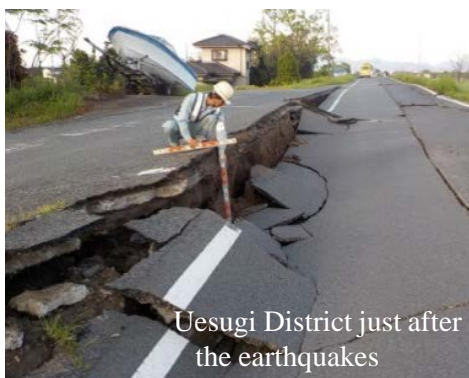
Uesugi District just after the earthquakes
