Challenging an Active Volcano

Unmanned Work at Mt. Unzen Fugendake

Unzen Restoration Project Office Kyushu Regional Construction Bureau Ministry of Construction

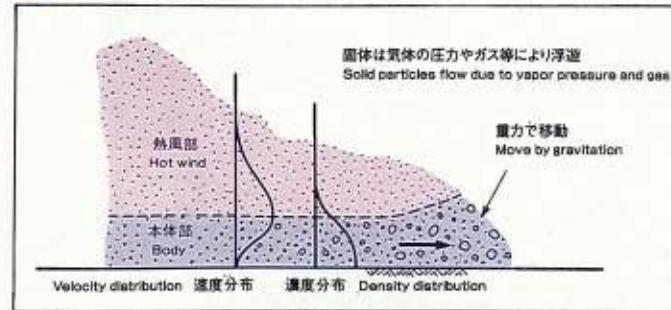
△火碎流のしくみ Mechanism of Pyroclastic Flow

火碎流は温度の高い溶岩が碎けたものや火山灰、火山ガスなどが混じって速いスピードで流れ下る現象で、火山活動の中でも最も恐ろしいもののひとつです。雲仙普賢岳では高温の溶岩ドームがつぎつぎと発生し、これが崩壊して火碎流となって山の斜面をかけ下ります。雲仙・普賢岳ではこれまでに約9,400回の火碎流が発生しており、1991年6月3日には死者・行方不明者43名という大災害となりました。この火碎流を発生させる溶岩ドームの崩れを予想することは非常に難しく、絶えず山を監視し火碎流に備える必要があります。

A pyroclastic flow is a volcanic phenomenon where crushed, high temperature lava mixed with volcanic ash and gases descends a mountain slope at high speed and is one of the most dangerous volcanic activities. Mt. Unzen Fugendake continuously produces high temperature lava domes which then collapse to general high speed pyroclastic flows. A total of about 9400 pyroclastic flows have so far been recorded at Mt. Unzen Fugenake, one of which occurred on June 3rd, 1991 which caused a serious disaster with 43 people declared either dead or missing. As it is extremely difficult to forecast the collapse of a lava dome leading to a pyroclastic flow, it is necessary to establish a permanent monitoring system to issue early warnings of pyroclastic flows.

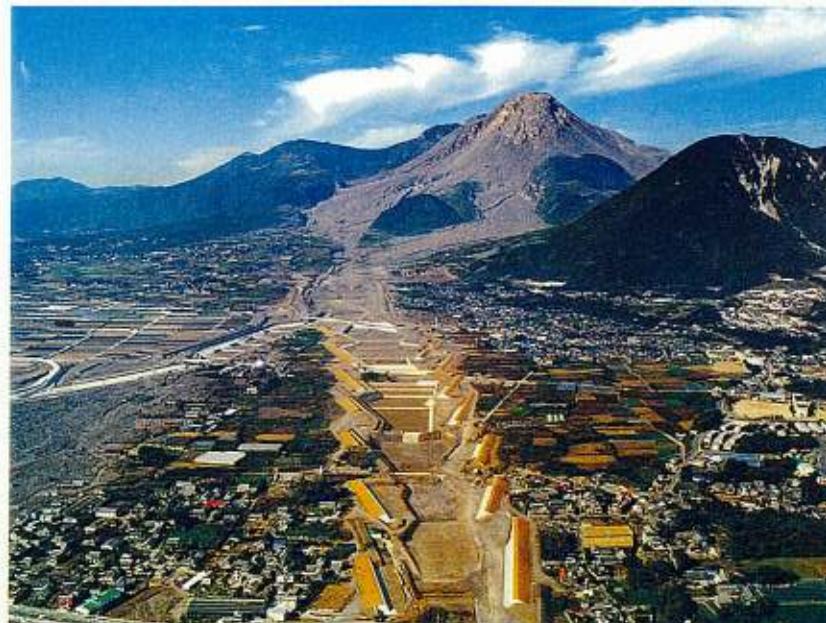
▲上空から見た導流堤 (1995.11.17 水無川) Aerial view of a training dike. (Mizunashi River)

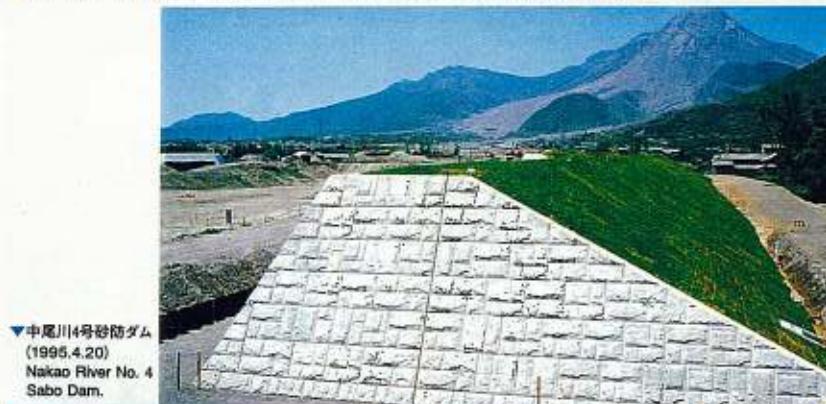
▼中尾川4号砂防ダム (1995.4.20)
Nakao River No. 4
Sabo Dam.

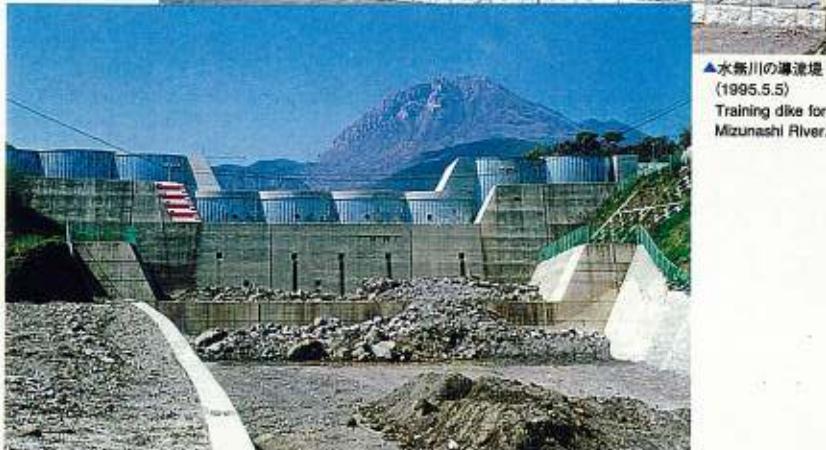
▲水無川の導流堤
(1995.5.5)
Training dike for
Mizunashi River.

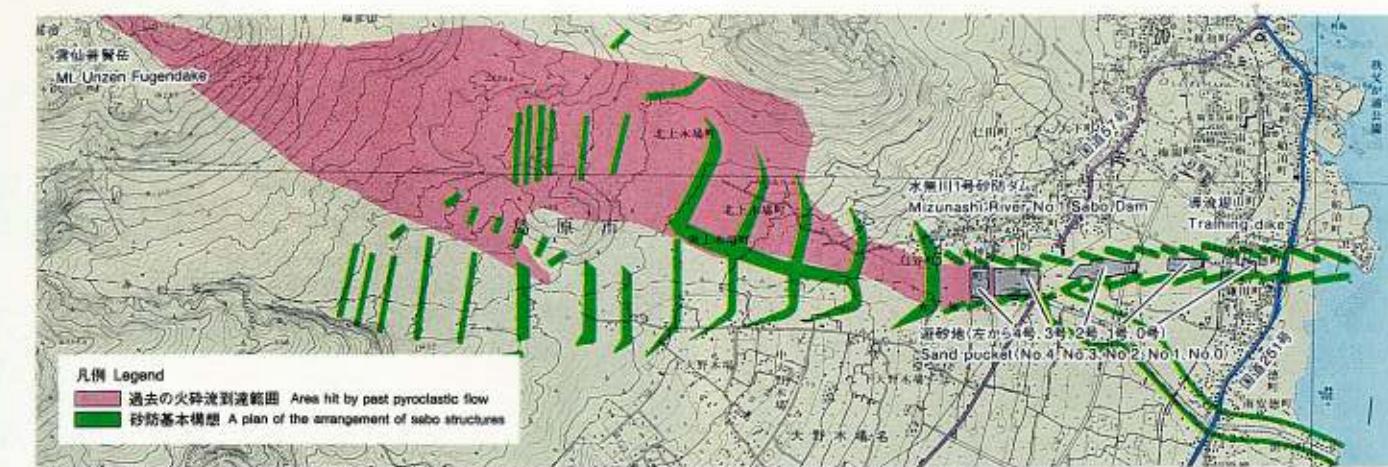
▲過去の火砕流 (1991.6.8) の到達範囲と砂防基本構想 (水無川) Area Hit by Past Pyroclastic Flow and Sabo Master Plan (Mizunashi River)

雲仙・普賢岳では、「土石流による災害から地域の安全を確保する」とともに、「災害に強いまちづくりや地域の振興などに寄与する」との基本方針のもとに、砂防基本構想が策定されています。この基本構想では、水無川や中尾川で砂防ダム群や導流堤といった砂防施設の建設が計画されています。

しかし、上流の砂防ダム群の工事予定地は雲仙・普賢岳直下のたいへん危険なエリアにあるため、当面、工事個所は作業員の安全確保が可能な下流域に限定されます。水無川流域では、上流から流下する土石流を周辺に氾濫させることなく、導流堤内に捕捉する遊砂地を緊急的に配置しています。

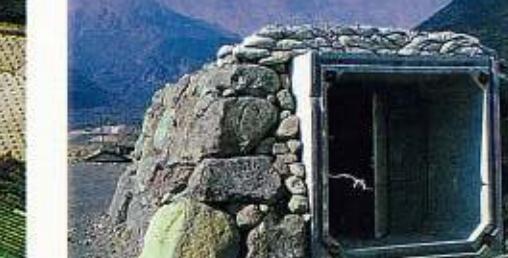
▲現場作業員の緊急避難施設 (1995.12.13)
Emergency shelter for site workers

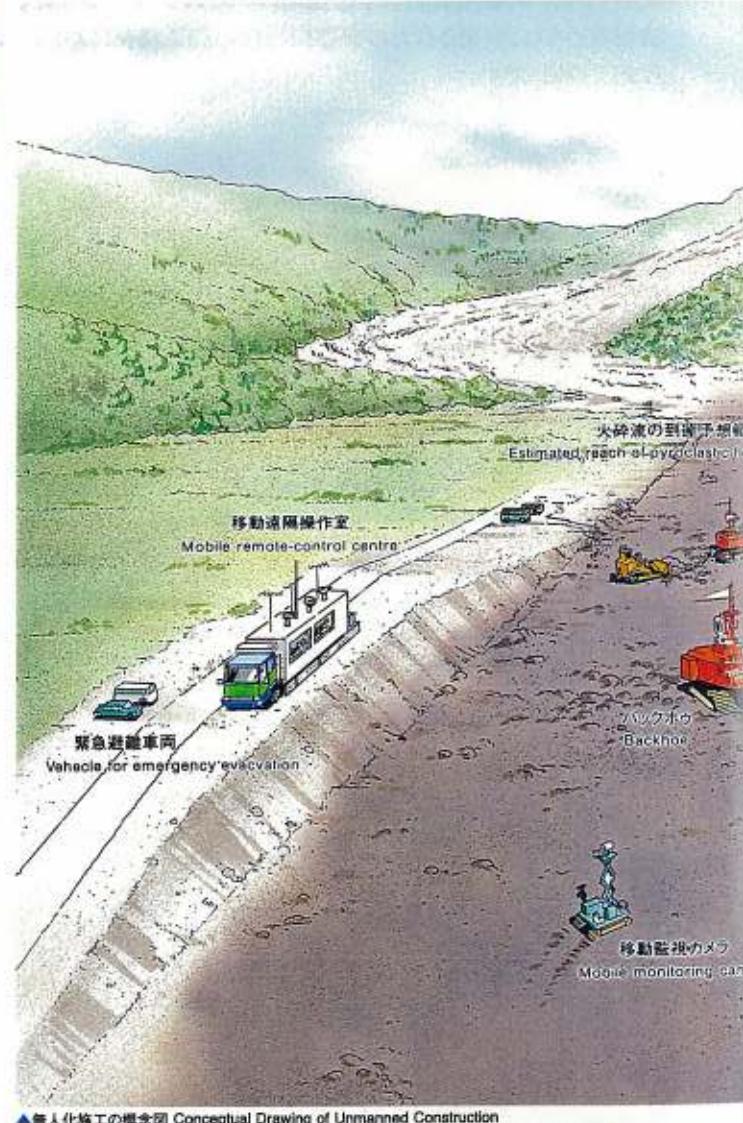
△無人化施工の概念図 Conceptual Drawing of Unmanned Construction

無人化施工に用いられる建設機械(ダンプトラック、バックホウ、ブルドーザ)には、作業状況を確認できるようカメラが搭載されています。また、建設機械のお互いの位置関係を把握するために移動カメラ車も配備されます。

オペレーターはカメラによる画像情報を頼りに安全な場所から建設機械を操作し、火碎流の危険性の伴う作業現場において堆積した土砂を運び出したり、砂防ダムの堤体打設を行います。

All the construction machines (dump trucks, backhoes and bulldozers) used for the unmanned work are equipped with a camera to monitor the state of the work. A vehicle with an independent camera is also stationed to check the relative locations of the construction machines. Using the images transmitted by these cameras, an operator gives instructions to each machine from a safe place to remove sediment from the work site where a danger of pyroclastic flow persists and to place concrete to construct the sabo dam body.

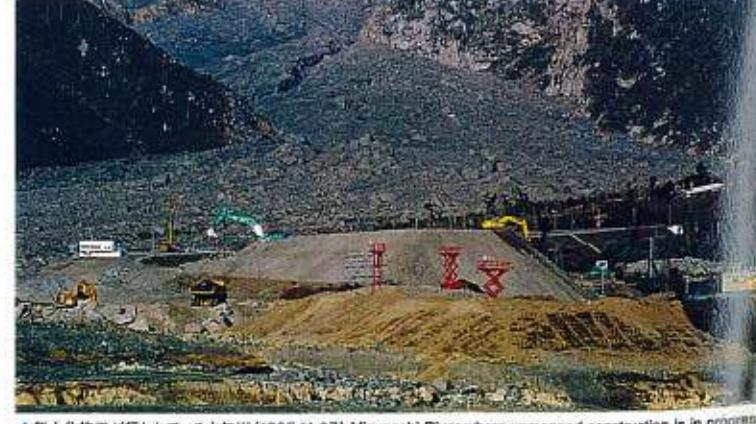
△無人化施工が行われている水無川 (1995.11.27) Mizunashi River where unmanned construction is in progress.

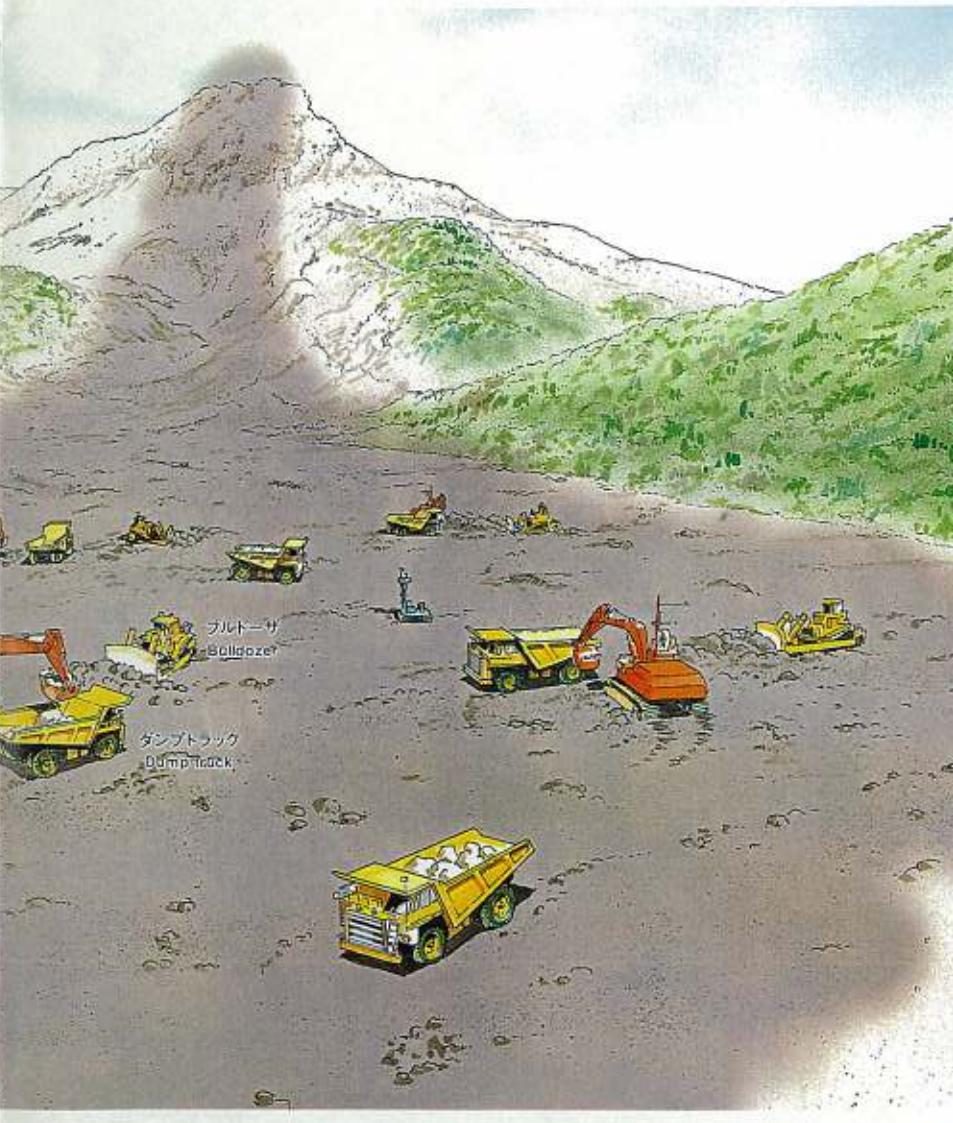
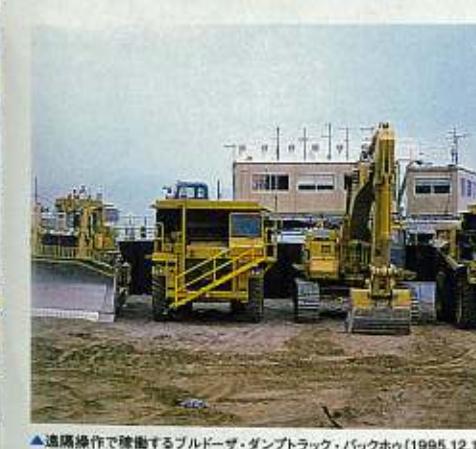
△遠隔操作で除雪するブルドーザ・ダンプトラック・バックホウ (1995.12.13)
Remote-controlled bulldozer, dump truck and backhoe in operation.

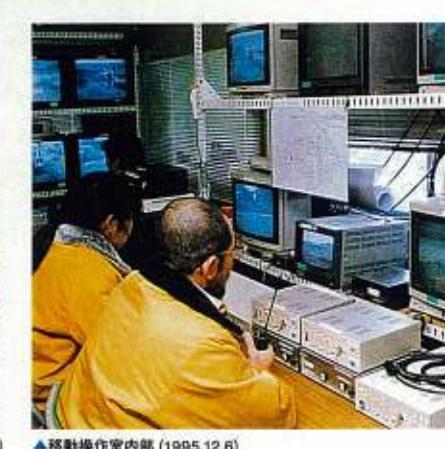
△移動操作室内部 (1995.12.6)
The Inside of the mobile remote-control centre.

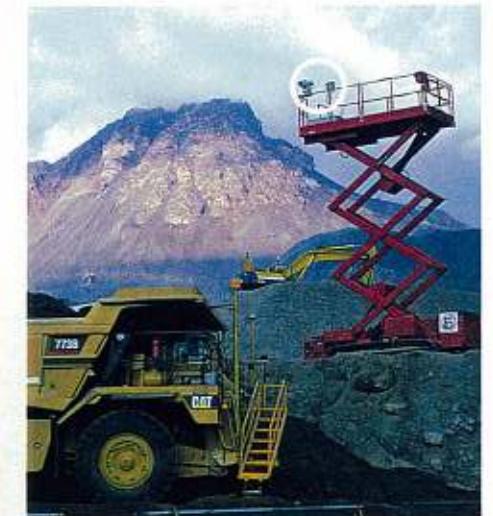
△移動監視カメラ (1995.12.13) Mobile monitoring camera.

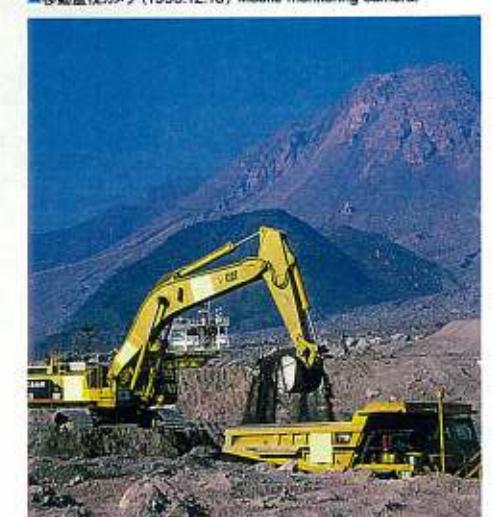
△無人のバックホウが土砂を掘削、ダンプトラックへ積み込む。(1995.12.13)
Excavation and loading of soil onto a dump truck by an unmanned, remote-controlled backhoe.

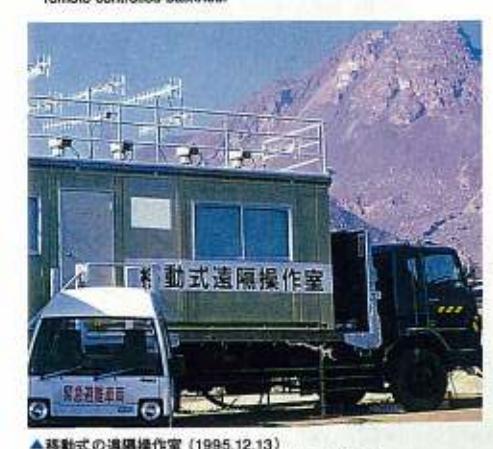
△移動式の遠隔操作室 (1995.12.13)
Mobile remote-control centre located in a vehicle .
