# THE WORST DISASTER IN JAPAN

## *The Catastrophe in Shimabara*

The 1791-92 eruption of Unzen-Fugendake and the sector collapse of Mayu-Yama

**Ministry of Land, Infrastructure and Transport of Japan**

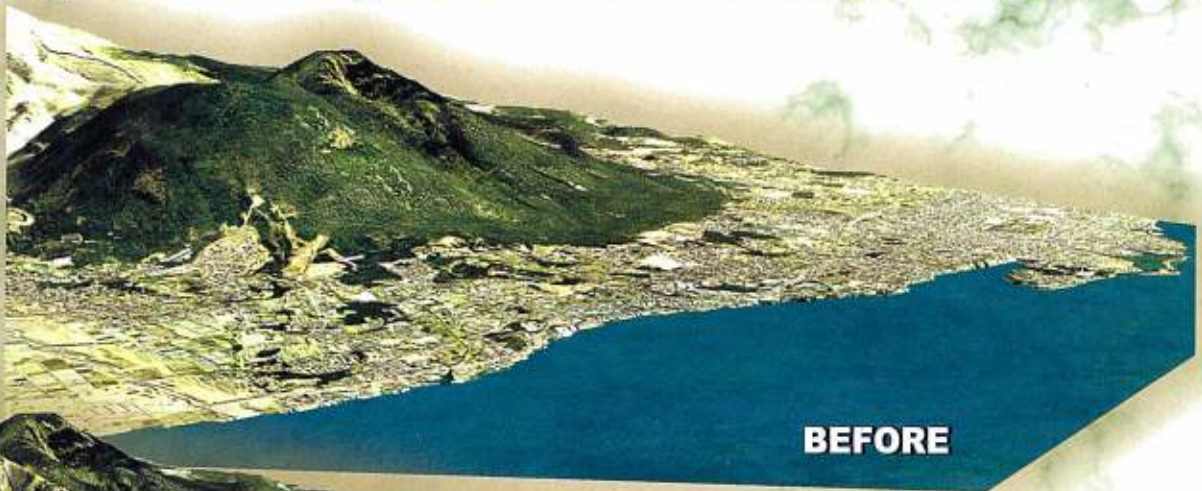
Gigantic sector collapse broke out. Huge amounts of debris and rocks rushed into Ariake Bay, and left a large number of debris flow mounds in the sea.

※ The bird's eye view of the cover was made by using the following materials.  
The topographic data of the land was made by Hokkaido Chizu Co. Ltd., on the basis of 1/ 25,000 map of the Geographical Survey Institute.  
The topographic data of the seabed was prepared by the Geographical survey Institute with narrow multi beam sounding system (Niwa, 1998).  
The aerial photograph was taken by the the Unzen Restoration Office.

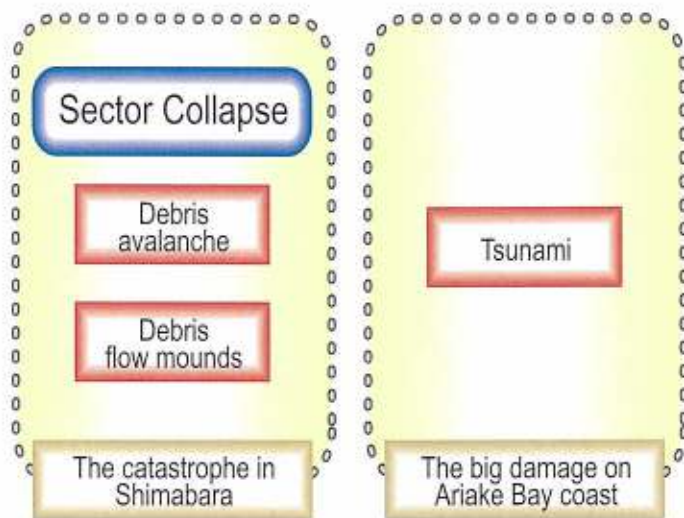
Fig.4 Outline of the 1792 event

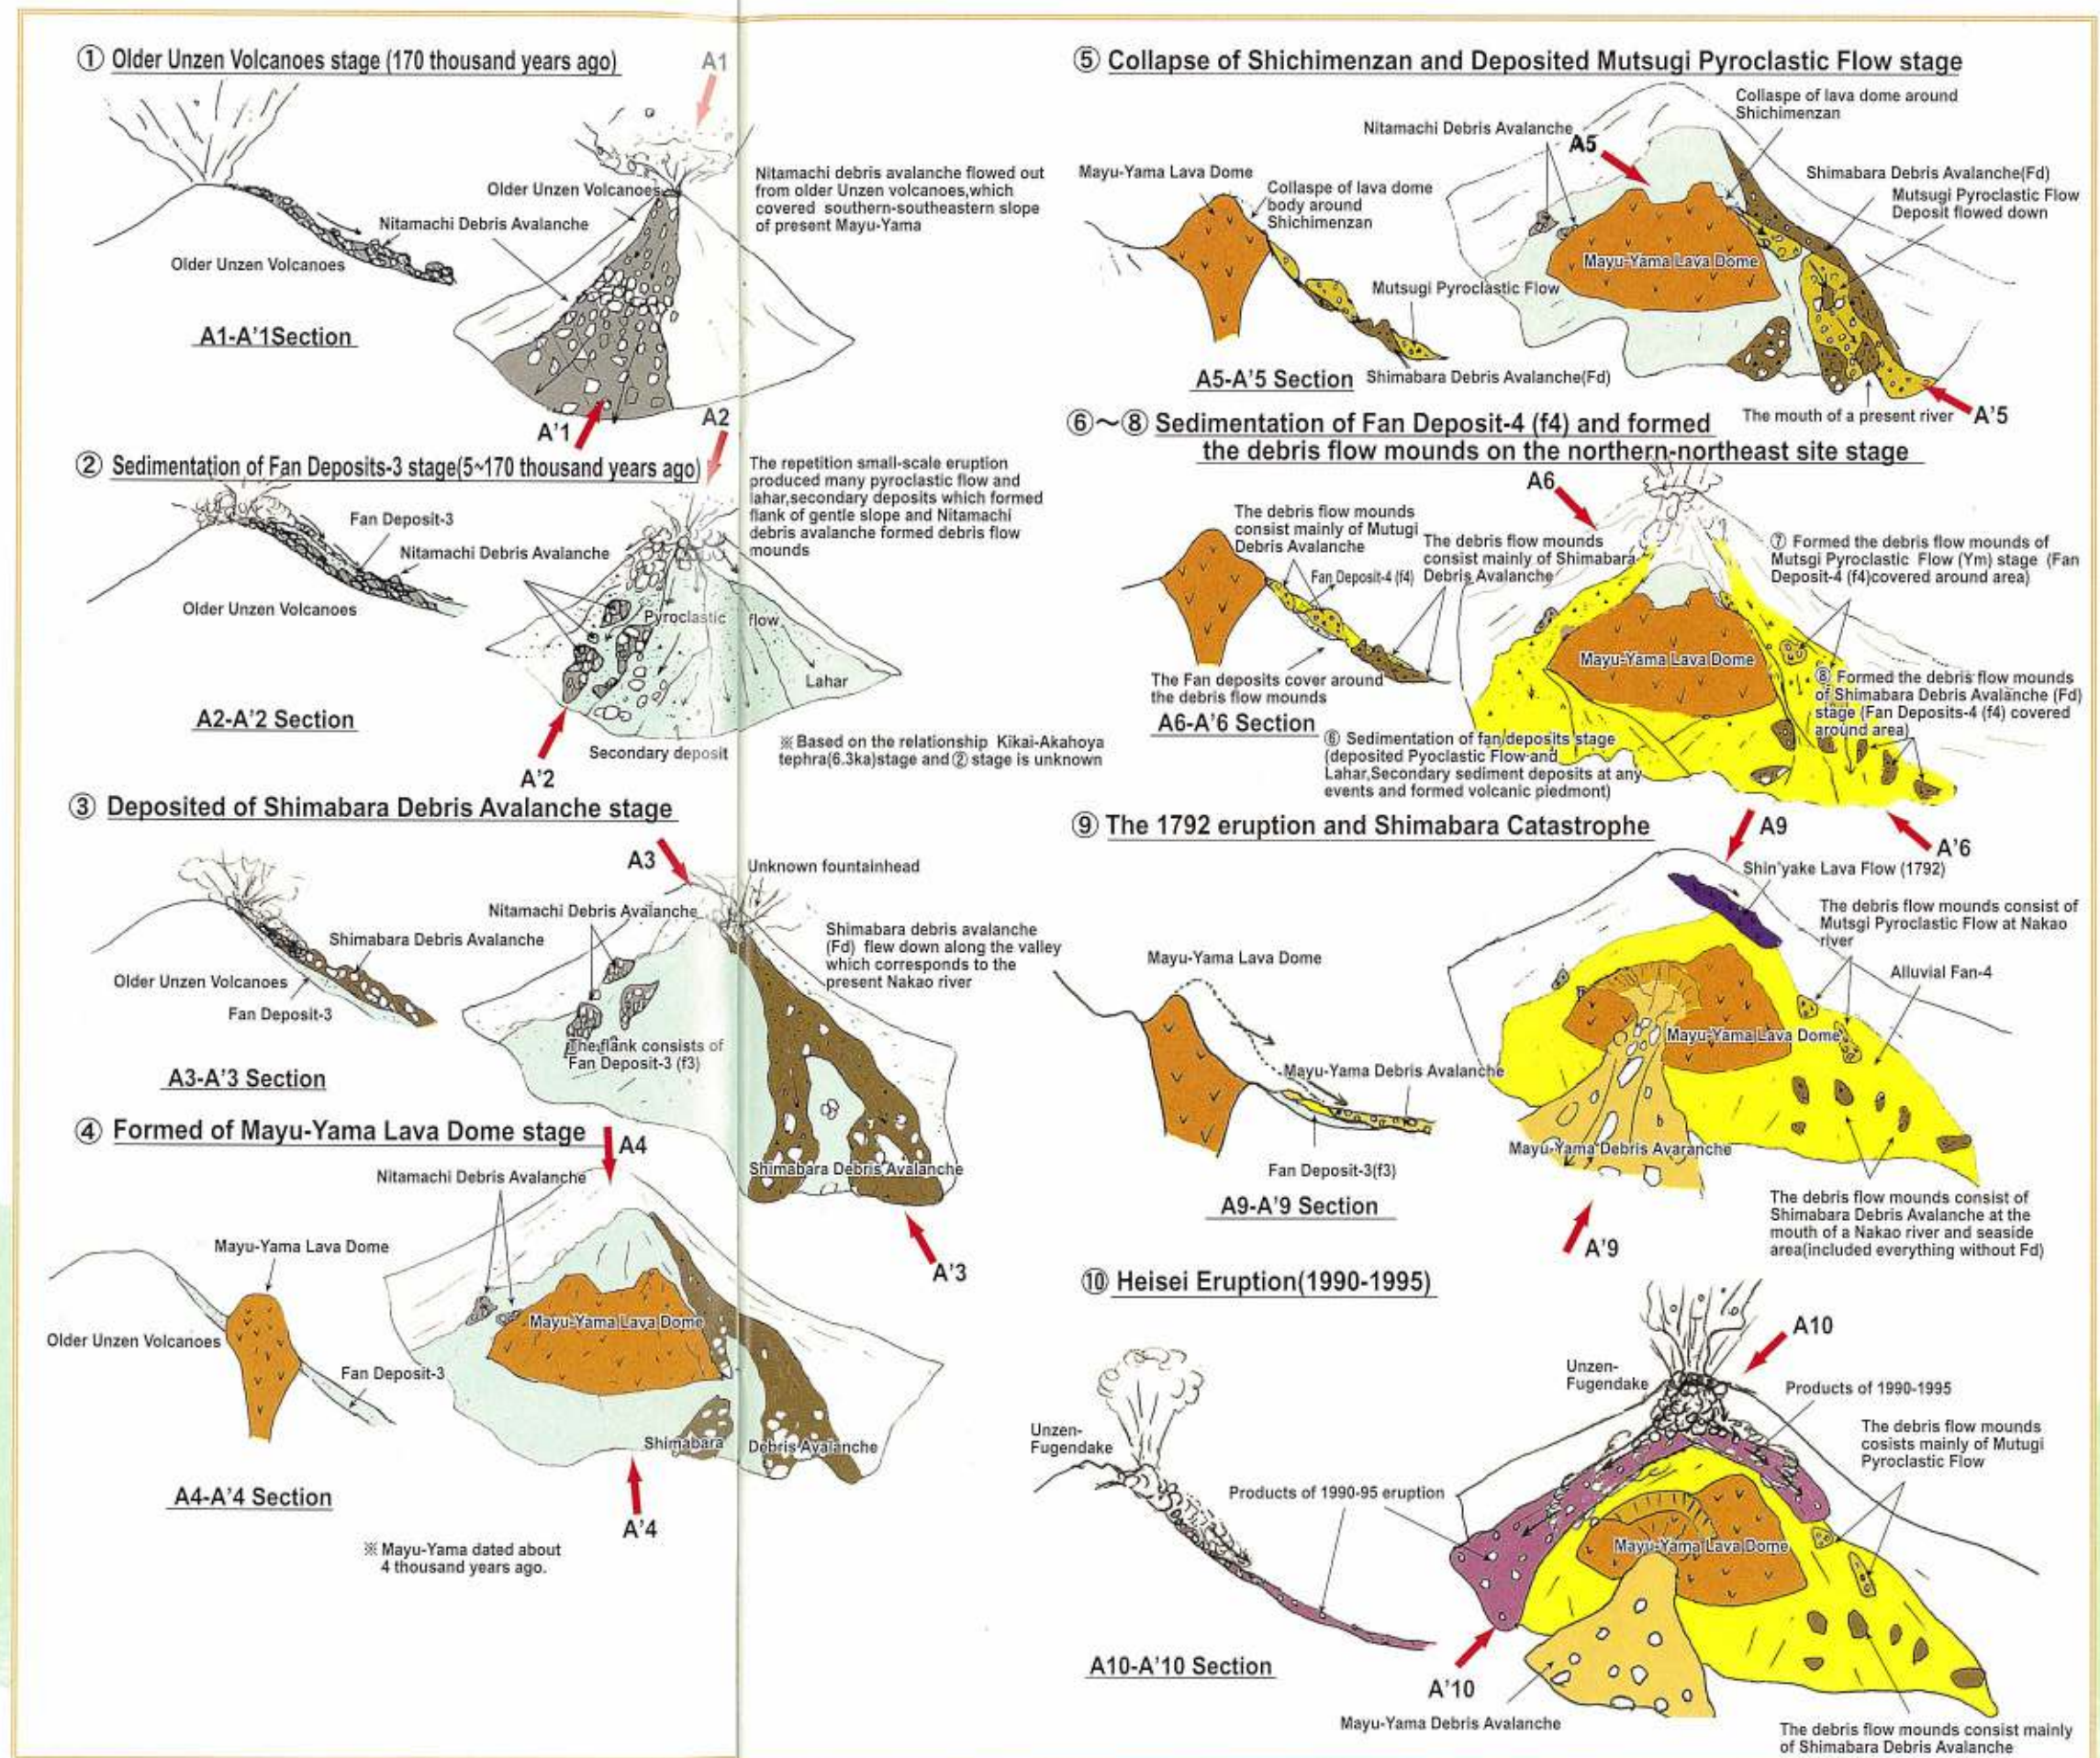
Fig.7 Conceptive pictures of the history of volcanic activity and topography formation around the Mayu-Yama

Consecutive pictures of the history of volcanic activity and topography formation around Mayu-Yama is shown in Fig.7.

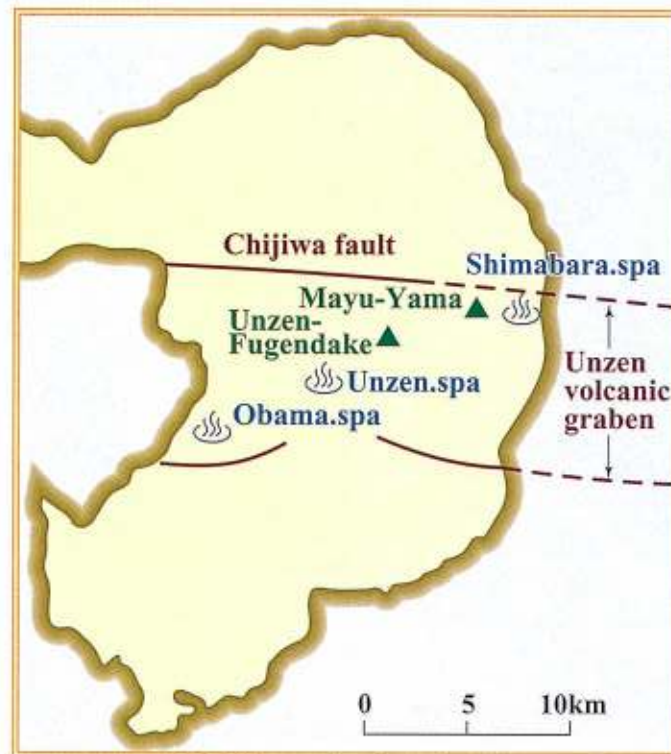
Fig.9 Unzen volcanic graben

Unzen volcano is a generic term of many mountains centering around Unzen-Fugendake in eastern part of Shimabara Peninsula. Unzen Volcanoes are situated in volcanotectonic depression area of Unzen graben. This graben continues extending the distance in the north-south direction. The graben forms many faults in the east-west direction, inducing earthquakes.

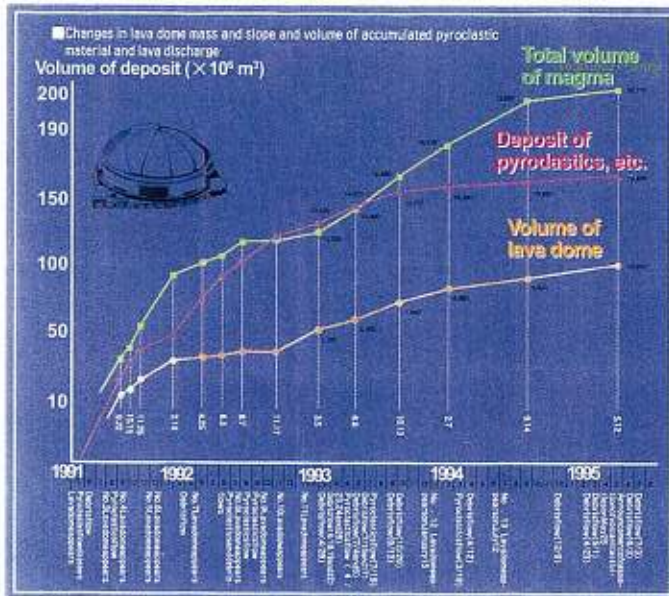
Fig.22 Changes in lava dome volume, talus and pyroclastic deposit volume, and lava discharge (Data of Public Works Research Institute and Geographical Survey Institute)

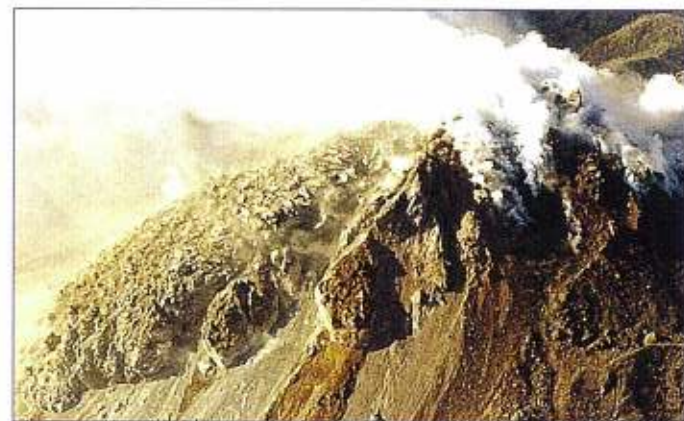
Photo.4 A still-growing lava dome (on Unzen-Fugendake photographed on October 1, 1993)

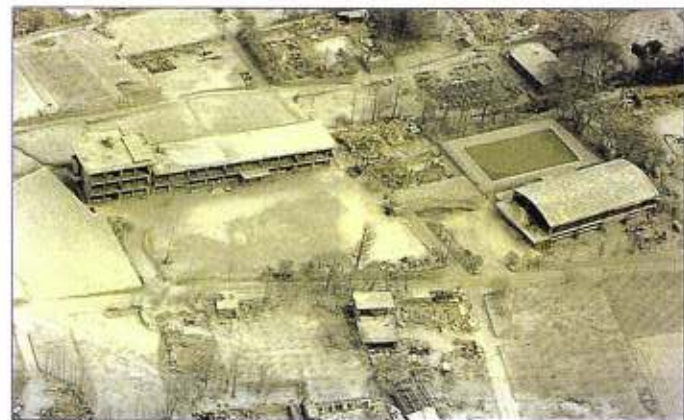
Photo.5 Ohno-Koba elementary school damaged by pyroclastic flows occurred on September 15, 1991

September 15 lava dome collapsed again, the large-scale pyroclastic flow occurred. It hit Taruki Hill, and changed the direction to Oshigatani. The main flow dashed along Mizunashi River. Ash cloud surge ran straight to Ohno-Koba hill. This surge burnt 218 houses including Ohno-Koba elementary school.

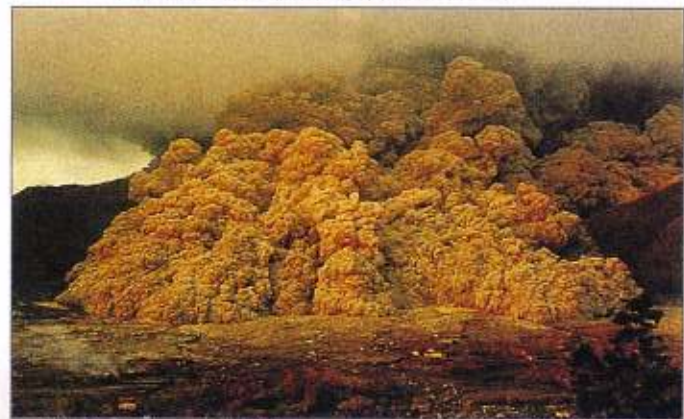
Photo.6 Pyroclastic flow occurred in Senbongi Plateau on June 24, 1993

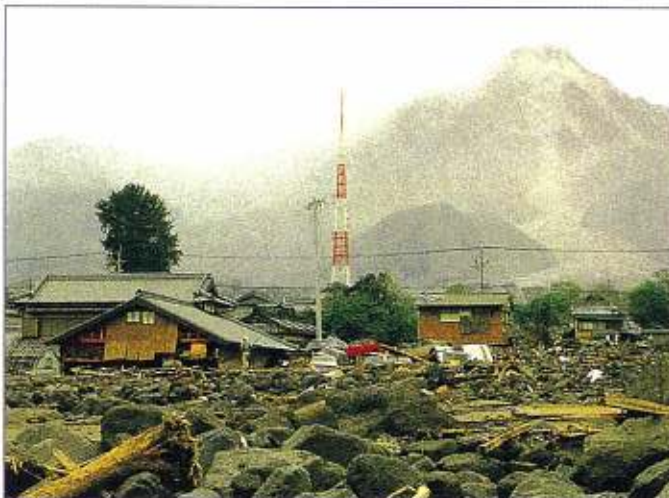
Photo.7 Aftermath of debris flows (Photographed on May 2, 1993)

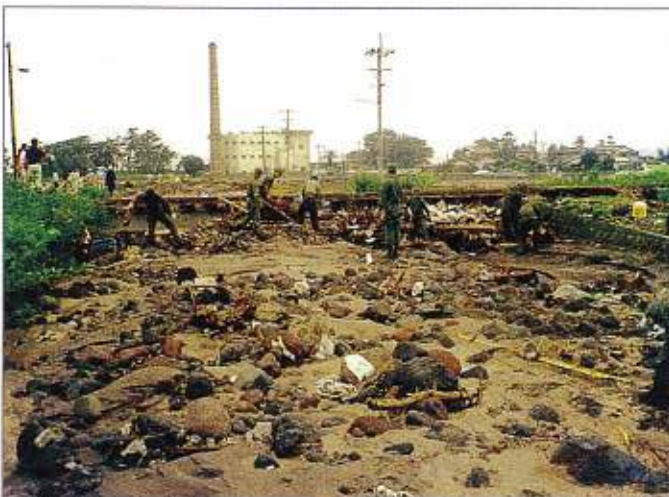
Photo.8 Debris flows occurred in Nakao River on July 4, 1993

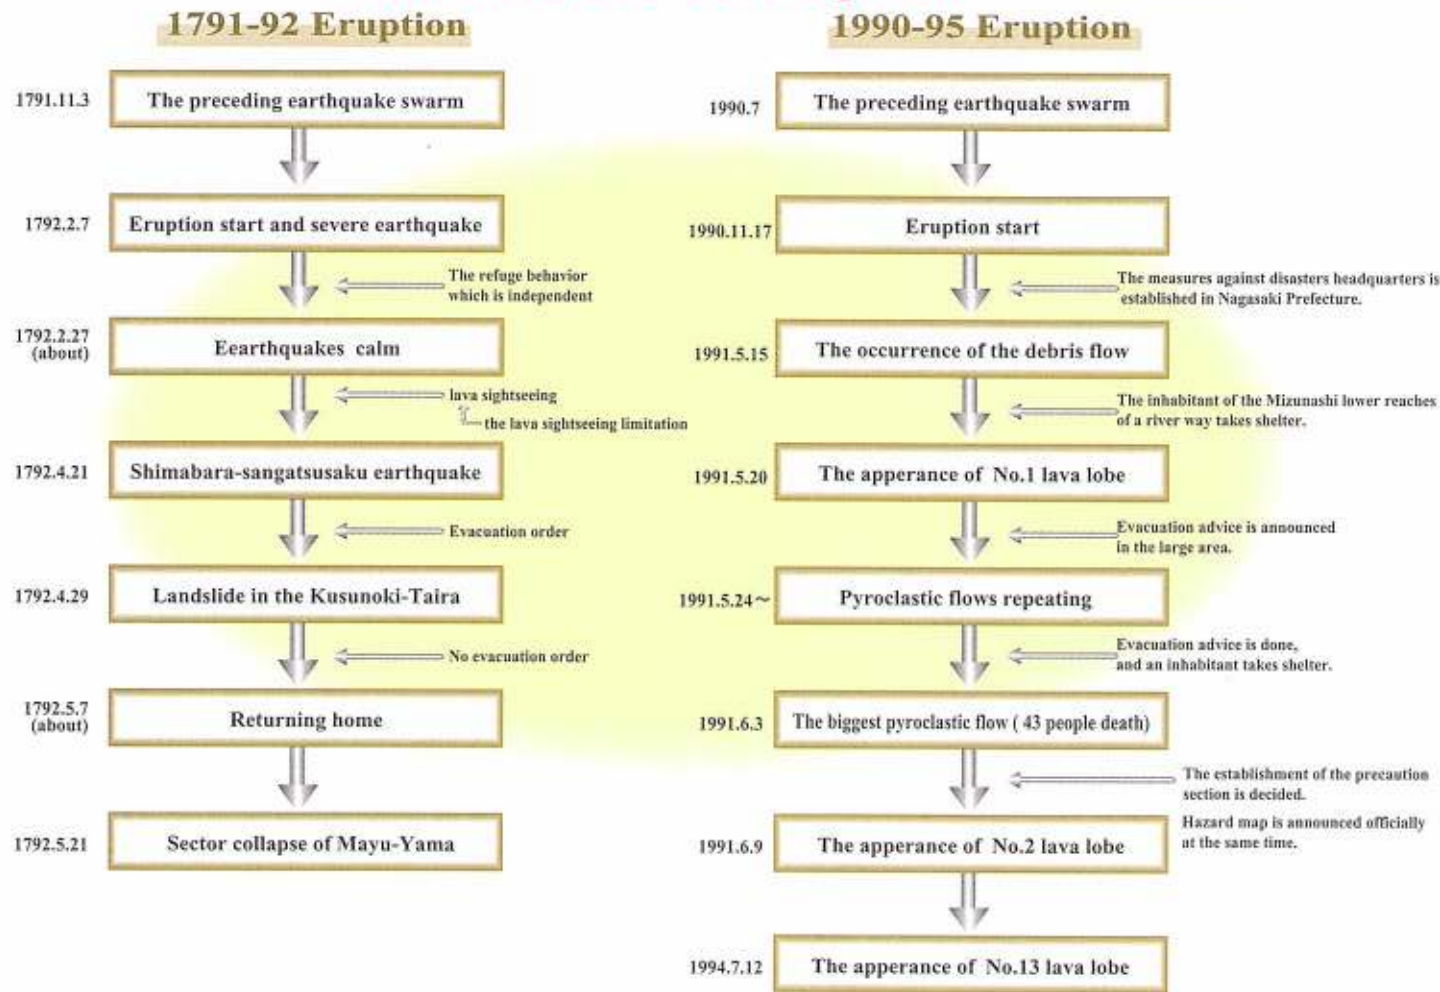
Fig.27 The comparison about volcanic activities and warning/evacuation arrangements

Volcanic activities and warning/evacuation arrangements were compared with the eruption in 1791-92 and 1990-95.

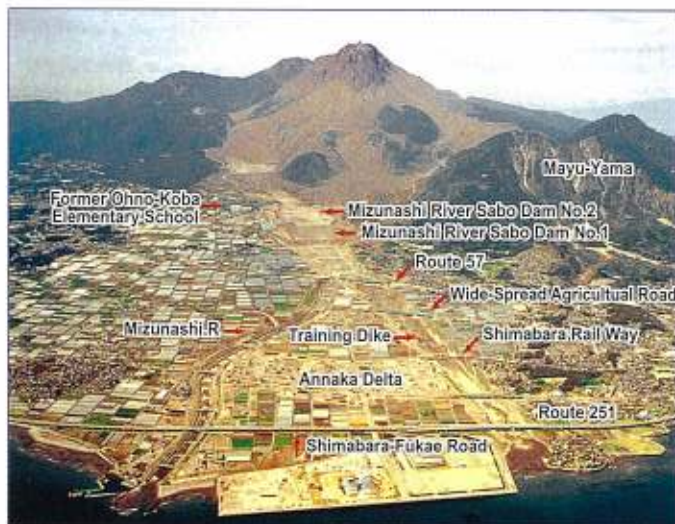
Projects in Mizunashi River Basin

In the basic plan, sabo dams were planned for capturing a debris flows above the sabo control points .

For countermeasures before sabo dams completion, training dikes and channel works were planned in order to control the direction of a debris flow and to prevent erosion and flooding between the sabo control points and estuary along Mizunashi River and Nakao River.

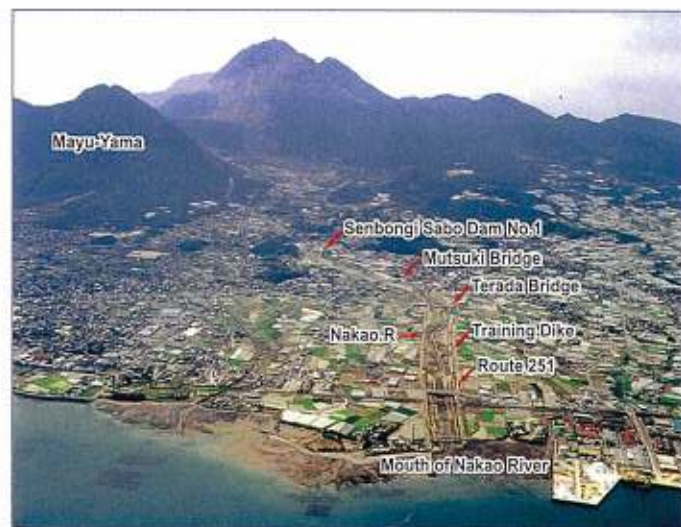
Projects in Nakao River Basin

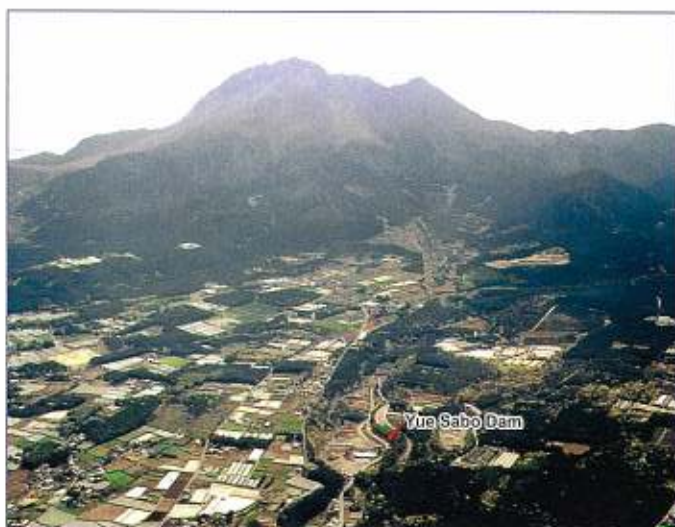
Projects in Yue River Basin

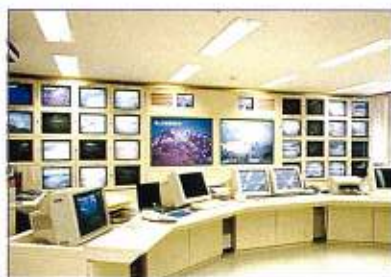
The disaster prevention information system : control room

The disaster prevention monitoring system which consists of ITV cameras, raingauges, and so on are prepared to secure the safety of the construction site and the area from the collapse of the lava dome and the debris flow. Disaster prevention information is transmitted to the construction site that people concerned through the watch point, and transmitted to the inhabitant through the related organization and Cable Television Shimabara.
